SCHROUD PROPERTY

CHICAGO, ILLINOIS

November 4, 2015

Title: CERCLA Preliminary Assessment (PA) for the Schroud Property

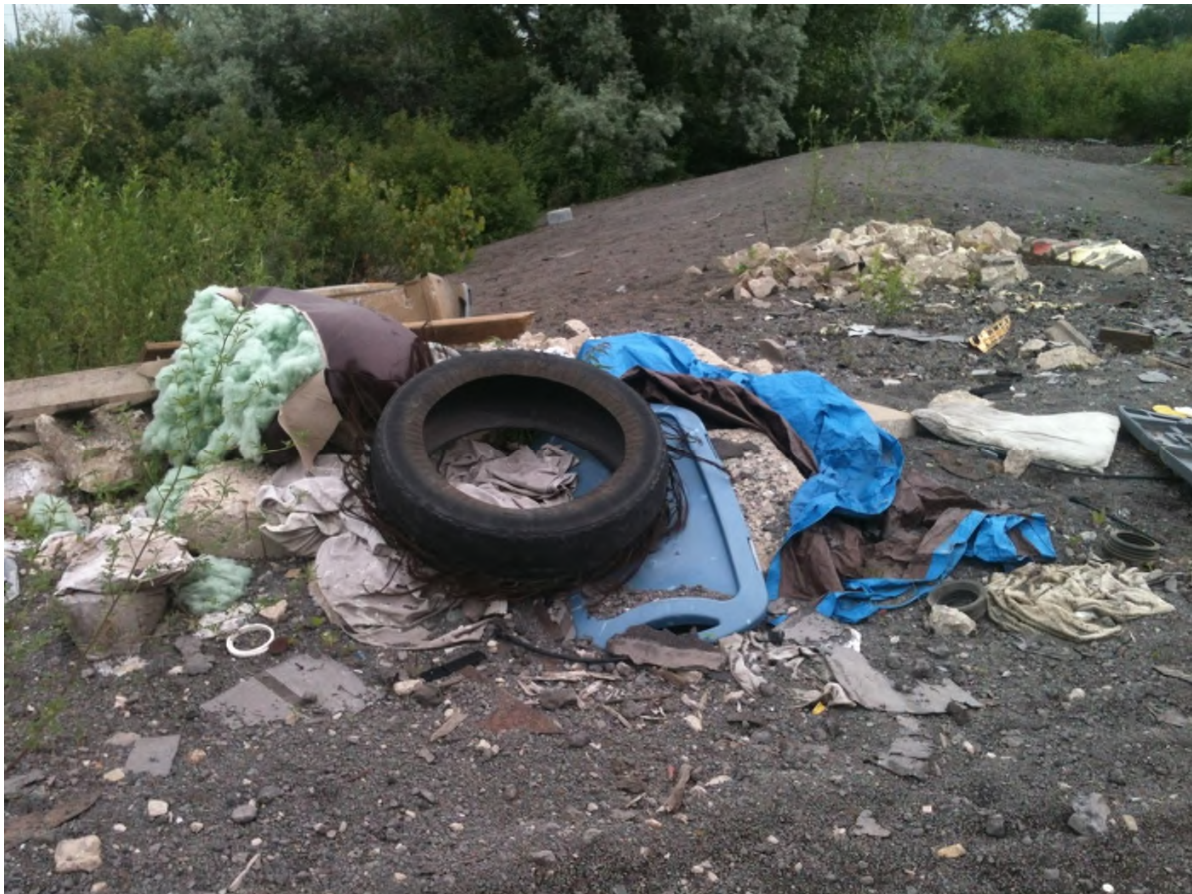
DATE: 7/8/15

NOTES: One of the many examples of illegal dumping on the Schroud Property

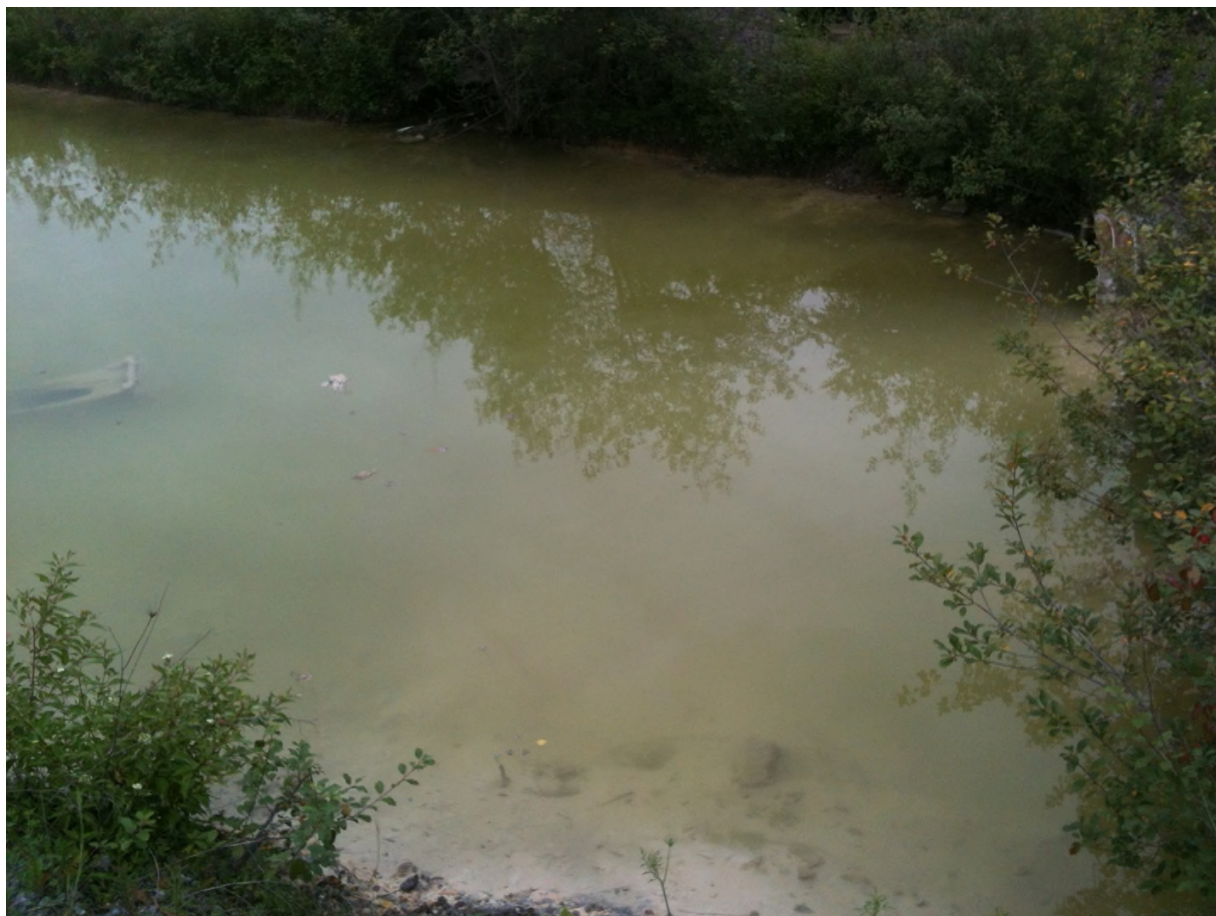
DATE: 7/8/15

NOTES: This is a photograph of Indian Creek right near XRF2 on Figure 6. Note the light-green discoloration of water as well as the unknown pale sediment at the bottom of the creek.

Surface water is also a significant concern at the site. Indian Creek flows through the property as it makes its way into the Calumet River. Slag piles and slopes create banks on Indian Creek, potentially exposing wildlife and sensitive environments to contamination. The target distance limit includes multiple wetlands and areas that could be used for fish consumption. Moreover, Indian Creek is a critical creek for spawning Chinook salmon, posing a threat to anadromous fish breeding grounds. The discoloration observed at the bottom of the creek may suggest the surface water route is affected by the Schroud Property.

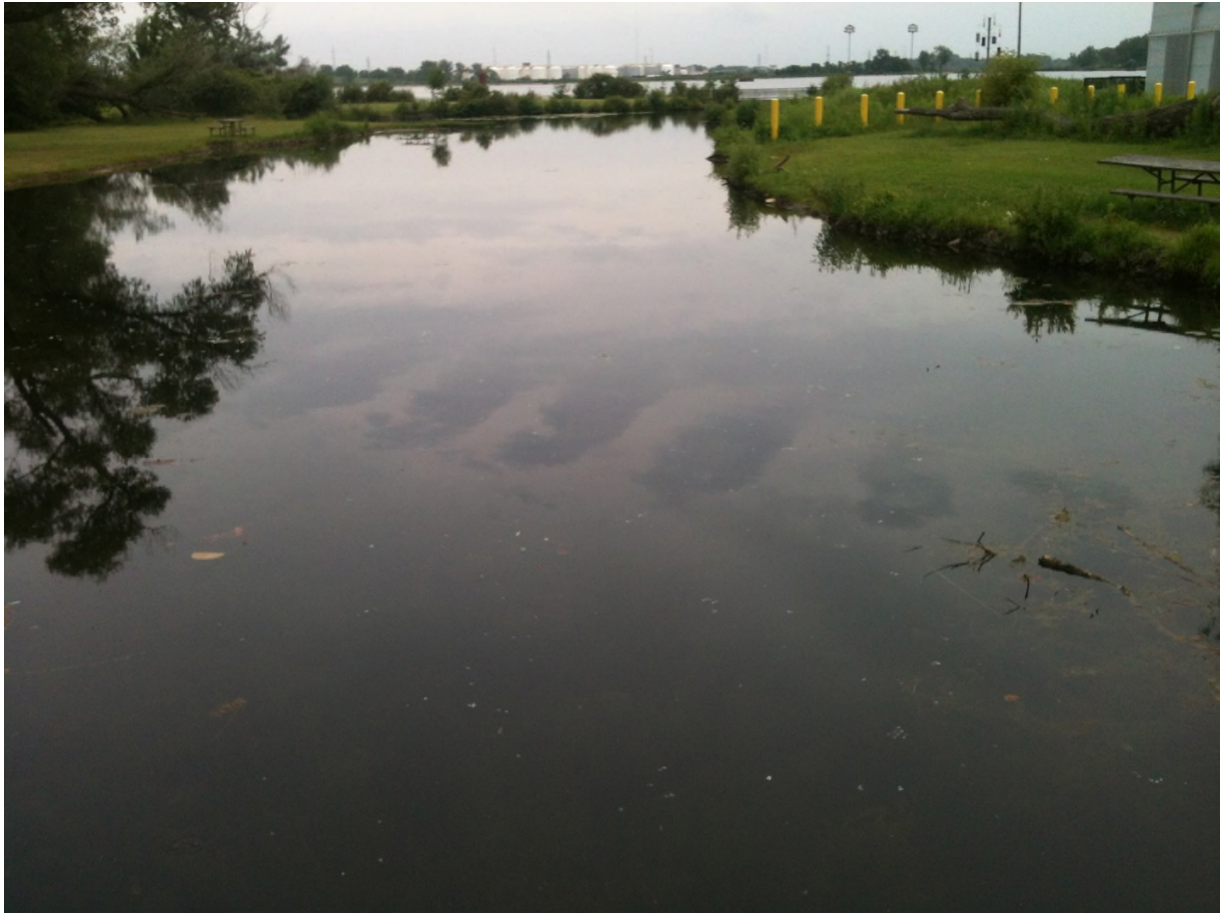
DATE: 7/8/15

NOTES: Indian Creek Headwaters at William Powers. Note Wolf Lake in the background. Also note how the water coloration is very different to that of Schroud Property. Water from Indian Creek at William Powers is a eutrophic brown versus the sickly light green recorded in the earlier photograph.

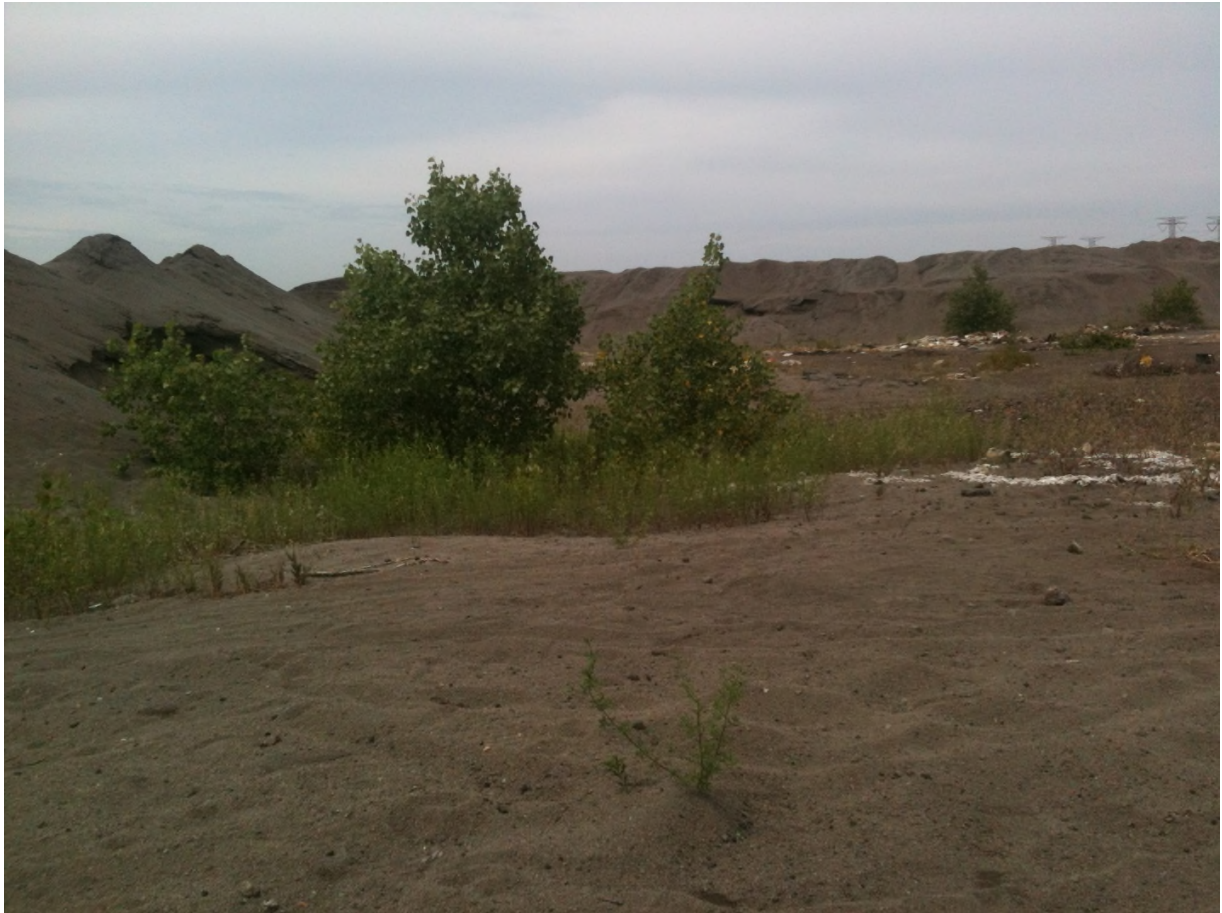
DATE: 7/8/15

NOTES: General scenery at the Schroud Property. Note the sparse vegetation and more examples of illegal dumping.

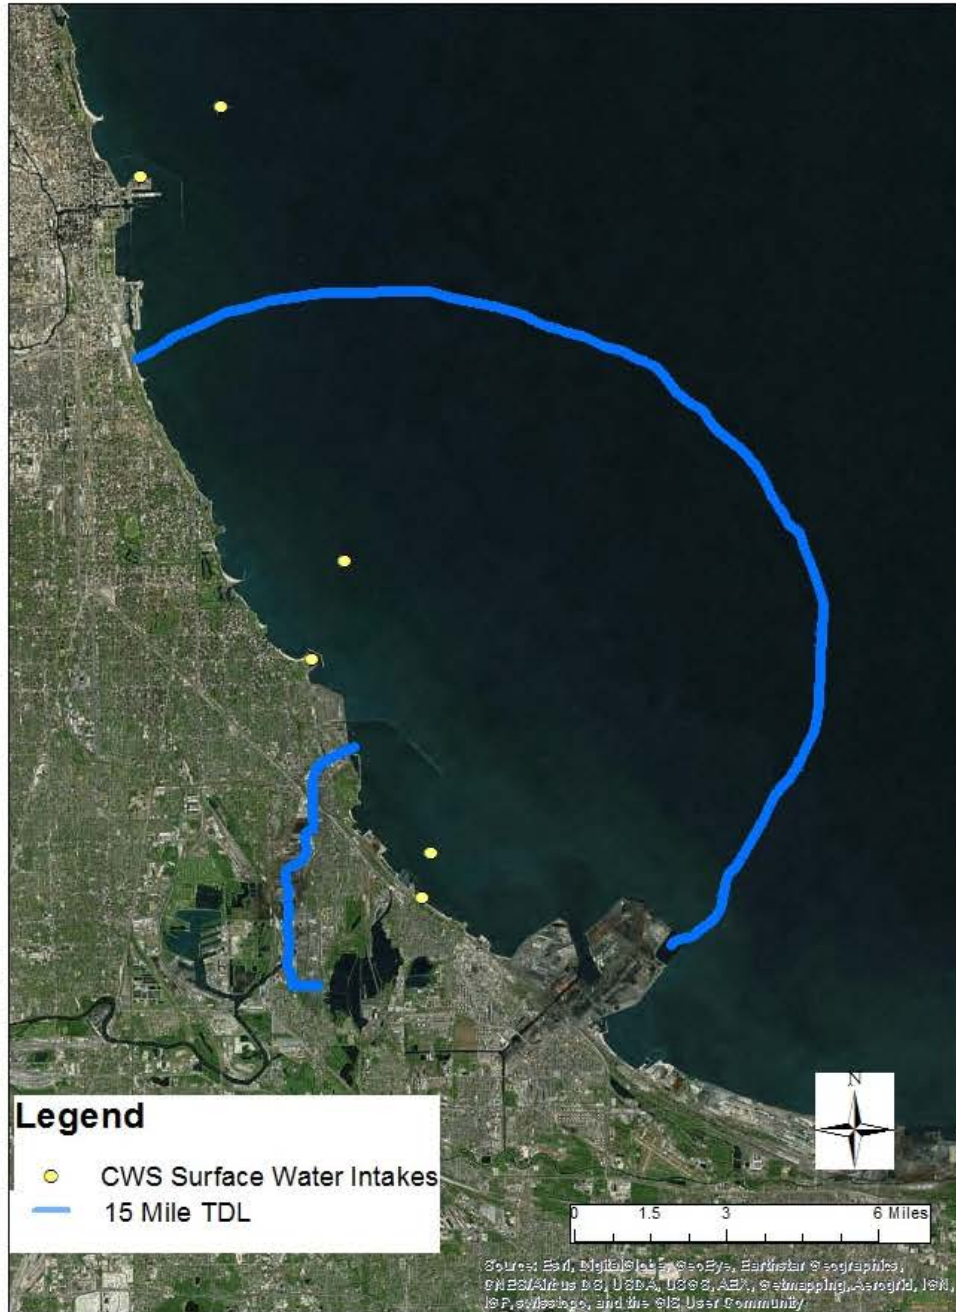
Figure 5
15 Mile TDL and Surface Water Intakes

The surface water pathway is a major concern of the Schroud Property. Due to un-vegetated slag piles that have significant slopes, there is a possibility that contents of the site can easily wash away in heavy rains. Portions of the Schroud Property are prone to flooding, increasing the risk of releasing materials into surface water (see Figure 7). The probable point of entry (PPE) from the Schroud Property into Indian Creek is along the entire on-property length of Indian Creek, which is located on the northern end of the property. Indian Creek flows from Wolf Lake, through the northern end of the property, to the Calumet River northwest of the property, then flows into Lake Michigan. The total in-stream distance from the Schroud Property to the mouth of the Calumet River at Lake Michigan is approximately five miles (see Figure 5).

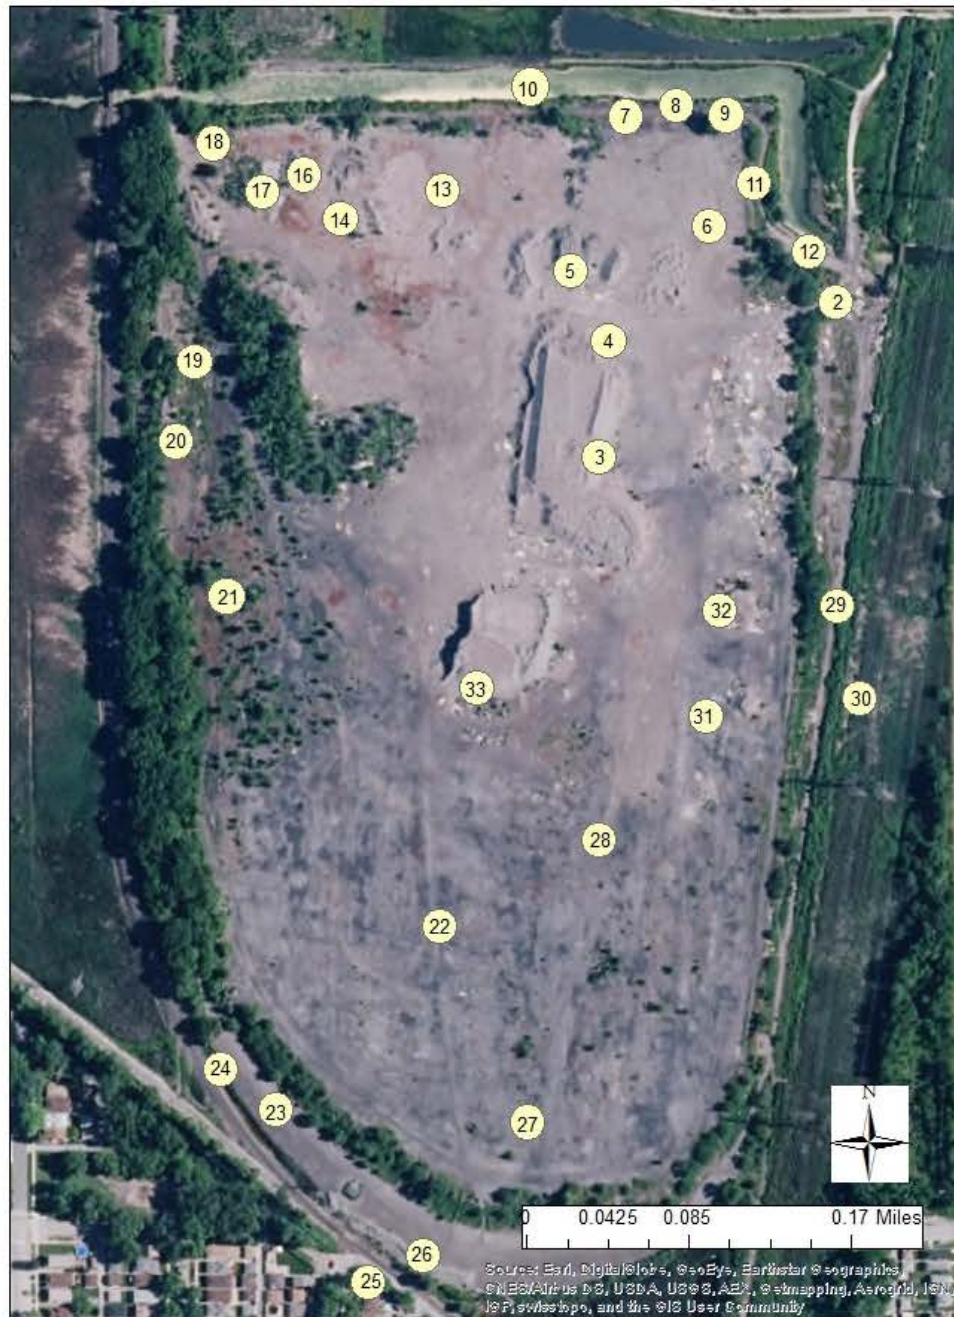
Figure 6
Approximate XRF Sampling Locations

During the reconnaissance, thirty-one (31) field screening samples were recorded by an Innov-X, X-Ray Tube (XRF) device (see Figure 6). The XRF device tests the soil for inorganic constituents (heavy metals): in this instance, lead, manganese, and chromium were of particular interest. XRF readings during this reconnaissance targeted multiple areas of the property, including multiple piles, soil around wetlands, soil near a residential property, and slag-soil mixtures.

- Refer to Figure 6 for sample locations
- All concentrations in parts per million
- Underlined and bolded figures indicates highest concentration found of metal
- If XRF test number is skipped, it either indicates error or calibration
